**NATIONAL  
TRANSPORTATION  
SAFETY  
BOARD**

**AIRCRAFT ACCIDENT REPORT**

CONTINENTAL AIR LINES, INC.,  
McDONNELL-DOUGLAS DC-10-10, N68045  
LOS ANGELES, CALIFORNIA  
MARCH 1, 1978

AAR-79-1

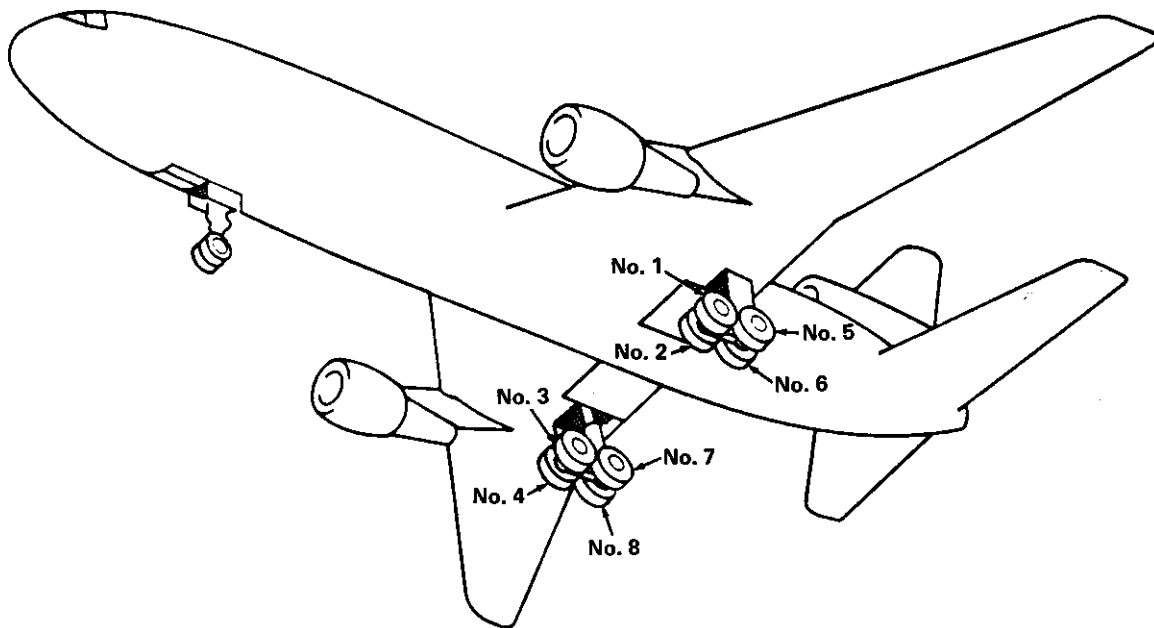
Figure 1. DC-10-10 main landing gear tire/wheel assembly positions.

The wheel, brake, and tire positions on the DC-10-10 main landing gear are designated by number; from left to right, beginning with the forward tires. (See figure 1.) **Nos. 1 and 2** are the forward positions on the left main gear, **Nos. 3 and 4** are the forward positions on the right main gear. **Nos. 5 and 6** are the aft positions on the left main gear, and **Nos. 7 and 8** are the aft positions on the right main gear. The tires in positions 4, 6, and 8 were on their first retread cycle; those in positions 3 and 5 were on their second retread cycle; and those in positions 1, 2, and 7 were on their third retread cycle. It was the company's policy to replace a tire after its third retread cycle.

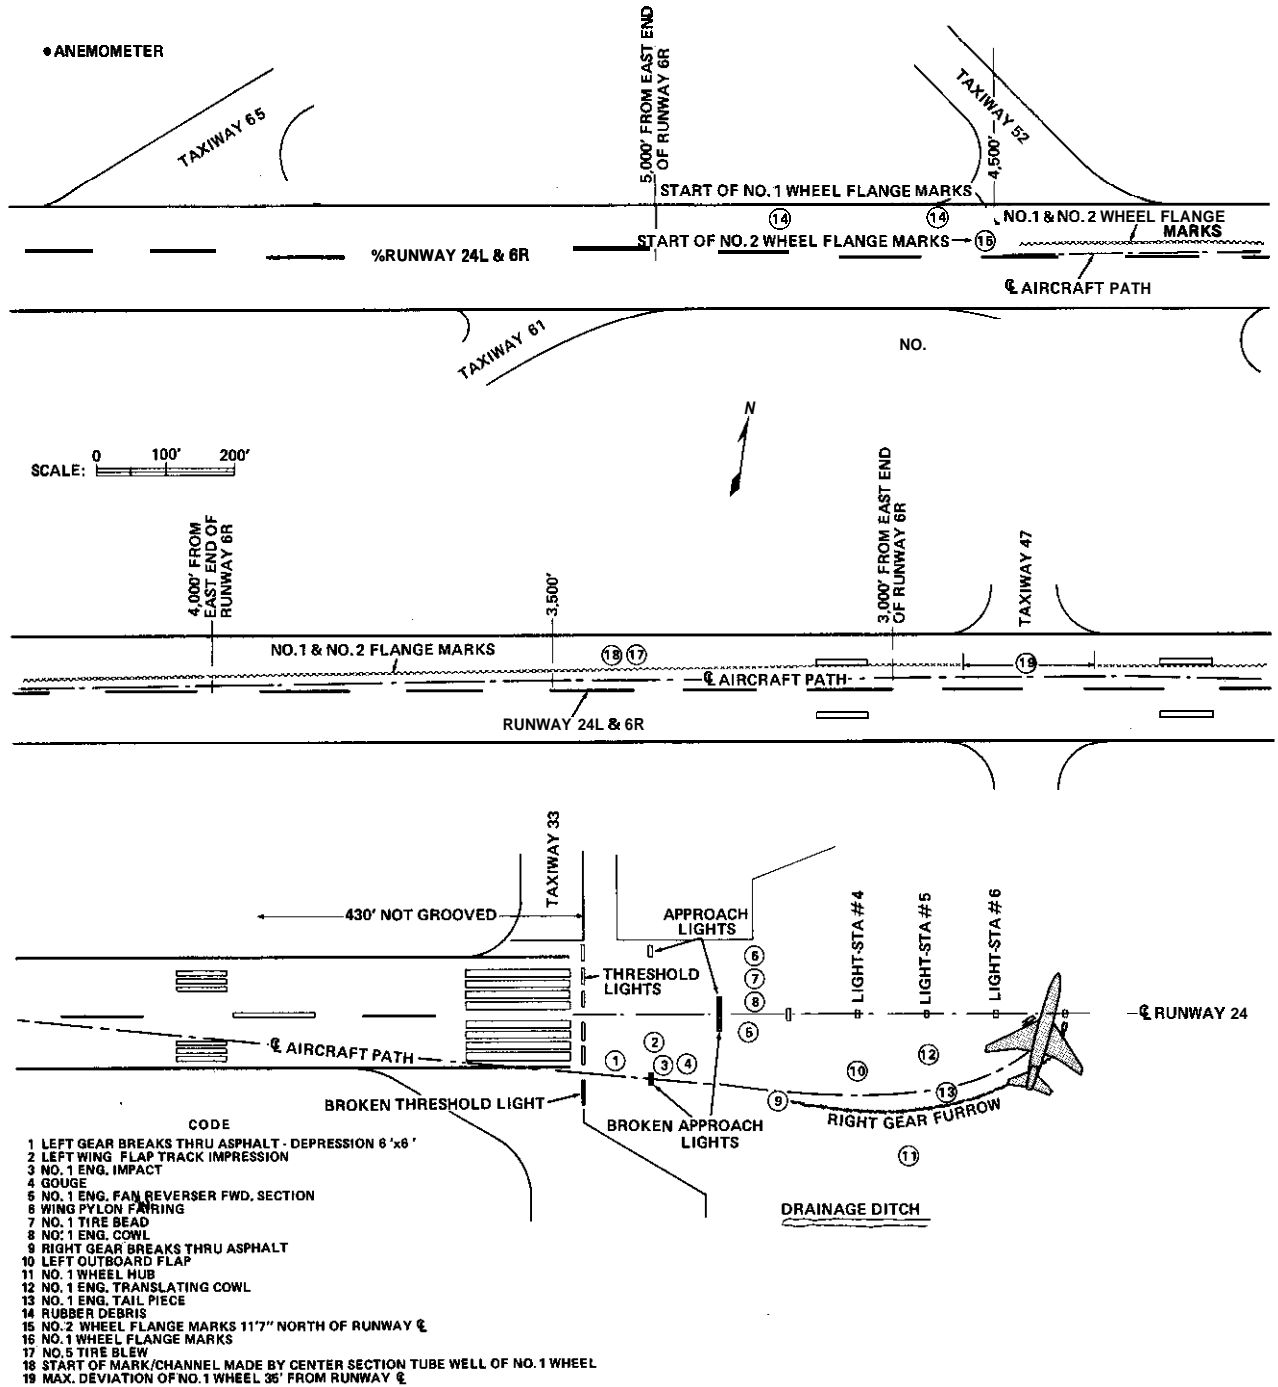
Figure 3. Aircraft wreckage distribution chart.

The event sequence was reconstructed based on marks left on the runway by the left main landing gear tire and wheel assemblies. The reconstruction showed that black marks from the No. 2 tire were evident beginning 6,300 ft from the departure end of runway 6R. These marks were spaced from 16 ins. to 20 ins. apart. With about 4,520 ft remaining, 6 in.-wide white squiggle marks from the No.2 tire were evident. With about 4,500 ft remaining, marks from both rims of the No. 2 wheel could be seen. Within the next 20 ft, marks from the inboard wheel rim of the No. 1 wheel appeared on the runway surface, with marks from both rims evident with 4,461 ft remaining. About 260 ft farther down the runway, bits of carcass ply were imbedded into the runway surface in line with the outboard rim of the No. 1 wheel. Marks from the tube well of the No. 1 wheel and from a piece of the No. 5 tire appeared at 3,403 ft and 3,380 ft, respectively. With about 1,575 ft remaining, all of the runway marks from the left main tire and wheel assemblies began to show evidence of shimmy. This characteristic continued until the aircraft left the runway surface. There were no signs of reverted rubber or other indications of hydroplaning on any tire or tire fragment. (See figure 3.)

The upper and lower auxiliary spar was torn off at the flap hinge fitting. Major fasteners connecting the support fitting to the wing box failed, except for the lower outboard 1 1/2-in.-diameter bolt connecting the support fitting to the wing box internal bulkhead, directly forward of the support fitting.

A trapazoidal portion of the wing rear spar web (about 3 1/2 sq ft) remained attached to the landing support fitting. This opened up the No. 1 fuel tank. The rear spar shear web and doubler had failed. A length of the vertical tang of the rear spar lower cap and a portion of the lower outboard cap of the wing chordwise internal bulkhead also remained attached to the landing gear support fitting. The wing bulkhead upper 1-in. bolts failed 1 in. aft of the rear spar web. The lower inboard 1 1/2-in.-diameter bolt was missing from its hole. A portion of the lower bulkhead cap remained on the lower outboard 1 1/2-in.-diameter bolt. A section of the rear spar web and vertical tang of the lower cap had broken loose at the outboard end of the landing gear fitting, which created a 1-sq-ft hole in the aft wall of the left compartment of the No. 2 fuel tank.
